HALLIWELL

RE:	Claim No.:	TBD
	DOCUMENT TYPE:	INVEST-ENGINEERING REPORT
	Date of Loss:	October 29, 2012
	Insurance Carrier:	Lexington London Insurance Company
	Insured Name:	Sand Castle Condominium
	Policy No.:	41LX006437850-8
	Location of Loss:	Sand Castle Condominium 384 Ocean Avenue Long Branch, NJ
	Independent Adjuster:	Mr. Richard Swink, NGA
	IA File No.:	YKFS-20861
	HEA Project No.:	12-997

The purpose of this investigation was to provide an engineering opinion as to the cause and origin of the reported damage to the roof and along the Exterior Insulated Finish System (EIFS) walls of the subject Condominium.

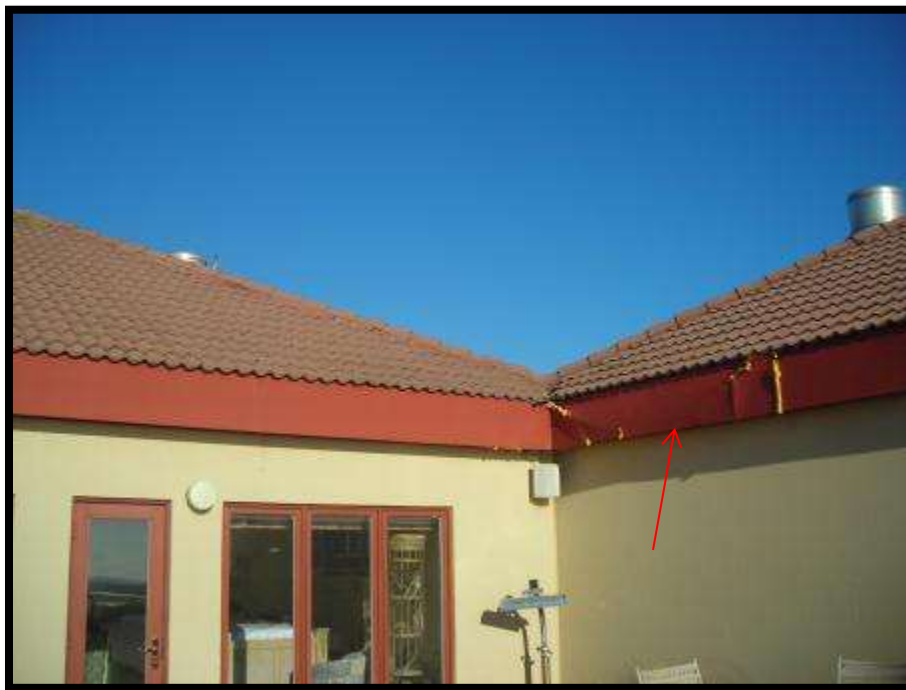
1. The metal siding along the fascia areas of the upper roofs was pulled outwards along some field and corner areas (Photos 2 through 5).
2. A limited number of tiles were dislodged and missing from some of the upper roof areas (Photos 6 and 7).
3. The roof membrane of the upper low sloping roofs was observed to be aged and deteriorated in several areas (Photos 8 and 9).
4. Roof field drains were observed that had missing roof drain screens (Photo 10).

The damage observed at the property along the exterior elevations of the subject building appears to have been related to the effects of wind. More particularly, the damage observed along the metal siding at the fascia of the upper roofs appears to have been a result of high wind.

The metal siding is a very flexible building element. When such a building element is subjected to negative pressures from higher than normal wind gusts associated to a building and the metal siding is fastened with a limited amount of fasteners to its substrate material, the metal siding would have a tendency to become dislodged from its substrate material and become distorted. This type of damage was observed by HEA along portions of the metal siding at the upper hip roof fascia areas.

Photo No. 2: Damage to metal siding along upper roof fascia (View from balcony of Unit 704).

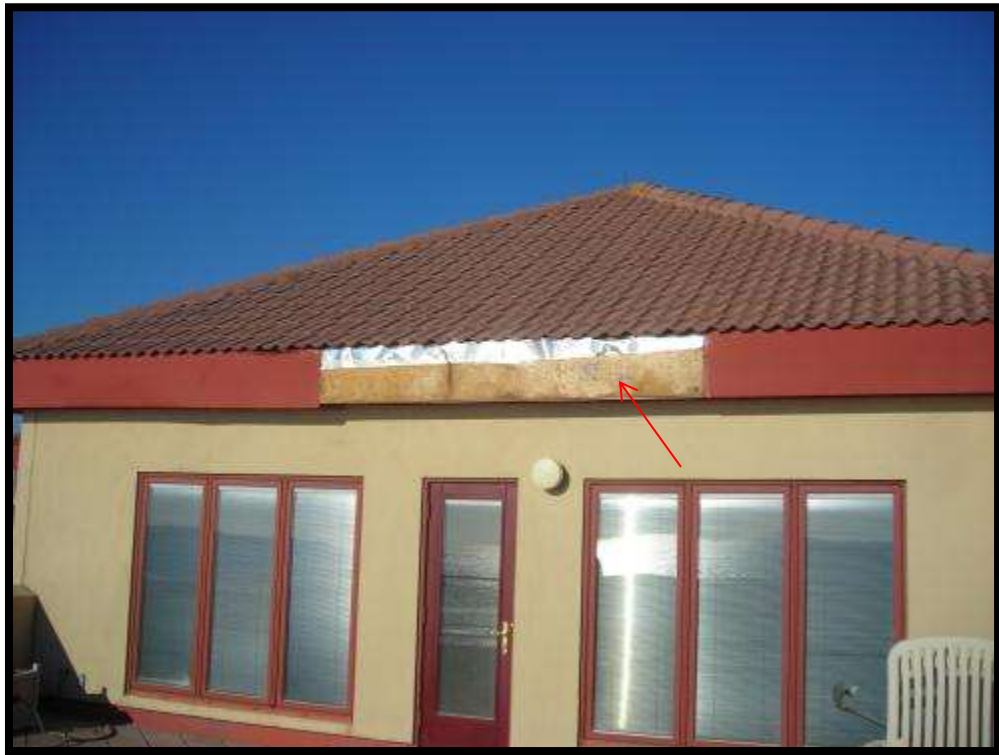
Photo No. 3: Damage to metal siding of upper roof fascia (View from balcony of Unit 701).

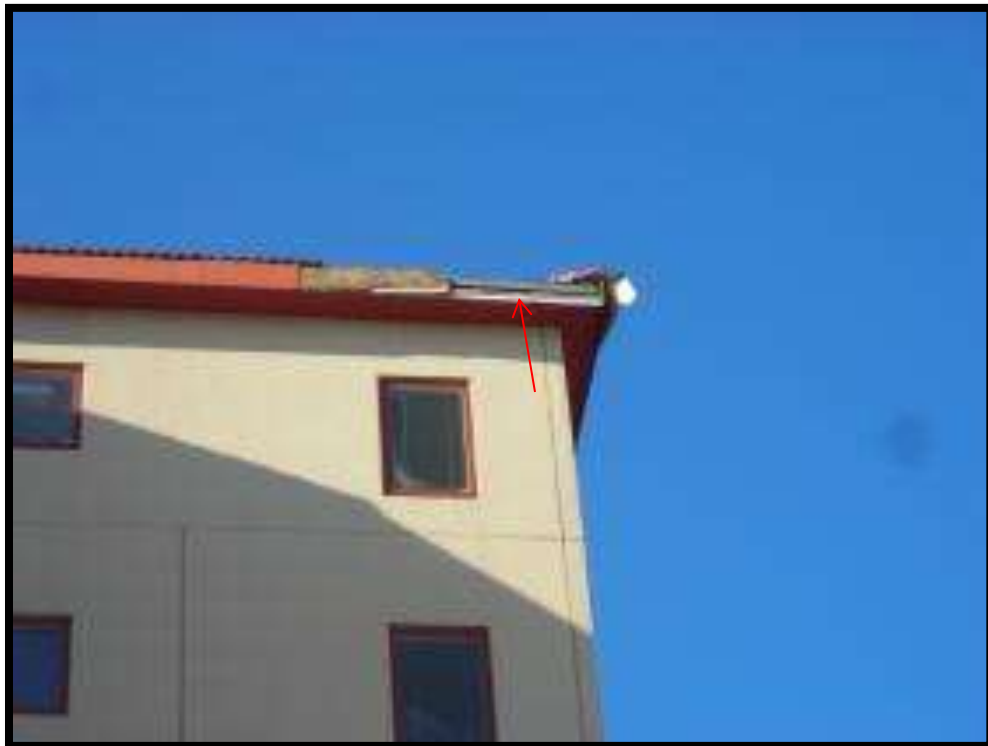
Photo No. 4: Damage to metal siding of upper roof fascia (North-east corner).

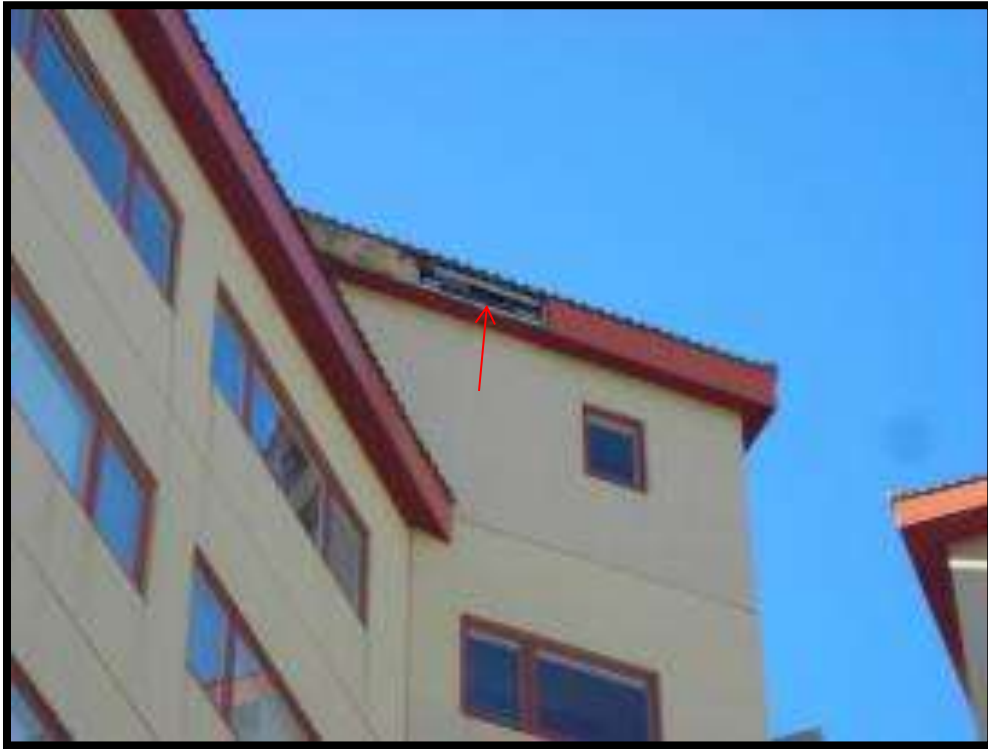
Photo No. 5: Damage to metal siding of upper roof (East elevation).

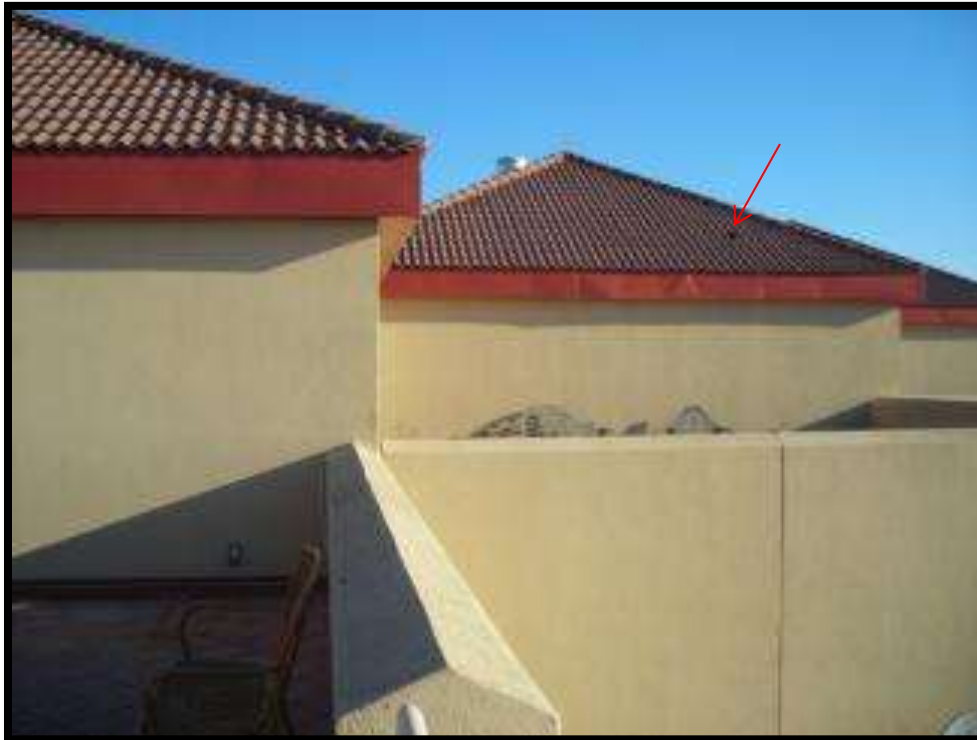
The limited amount of roof tiles found to have been dislodged and/or missing from the upper level roofs suggests that the actual event wind speeds were not excessive as compared to the wind speeds this building was to have been designed for.

Photo 6: Missing/dislodged roof tile along upper roof (View from balcony of Unit 704).

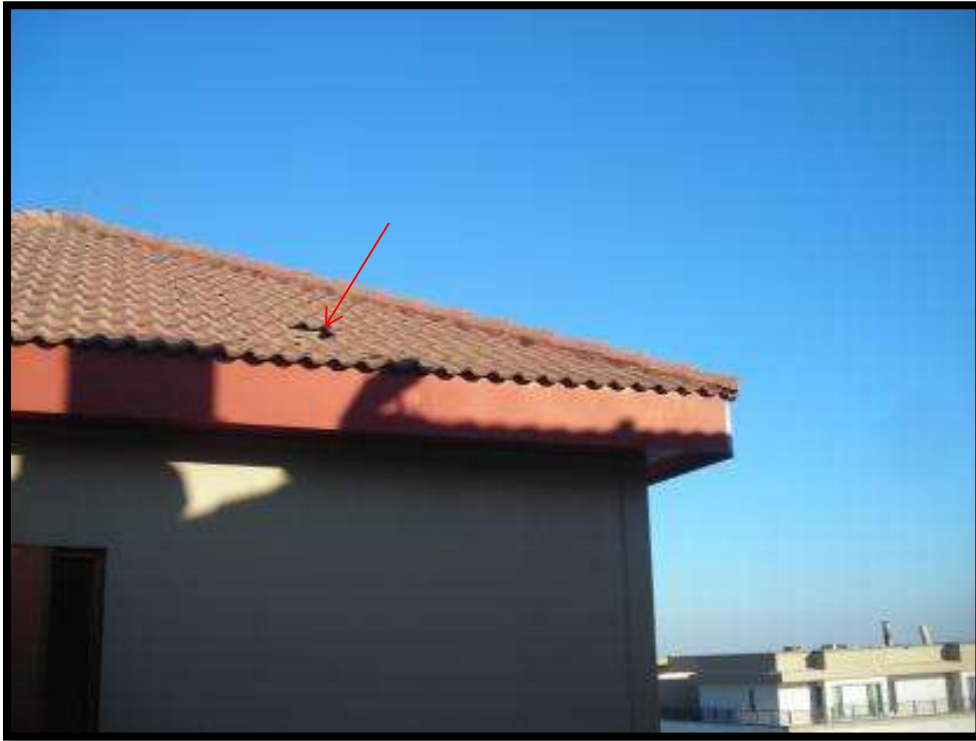
Photo 7: View of missing/dislodged roof tile (View from low-sloped upper roof).

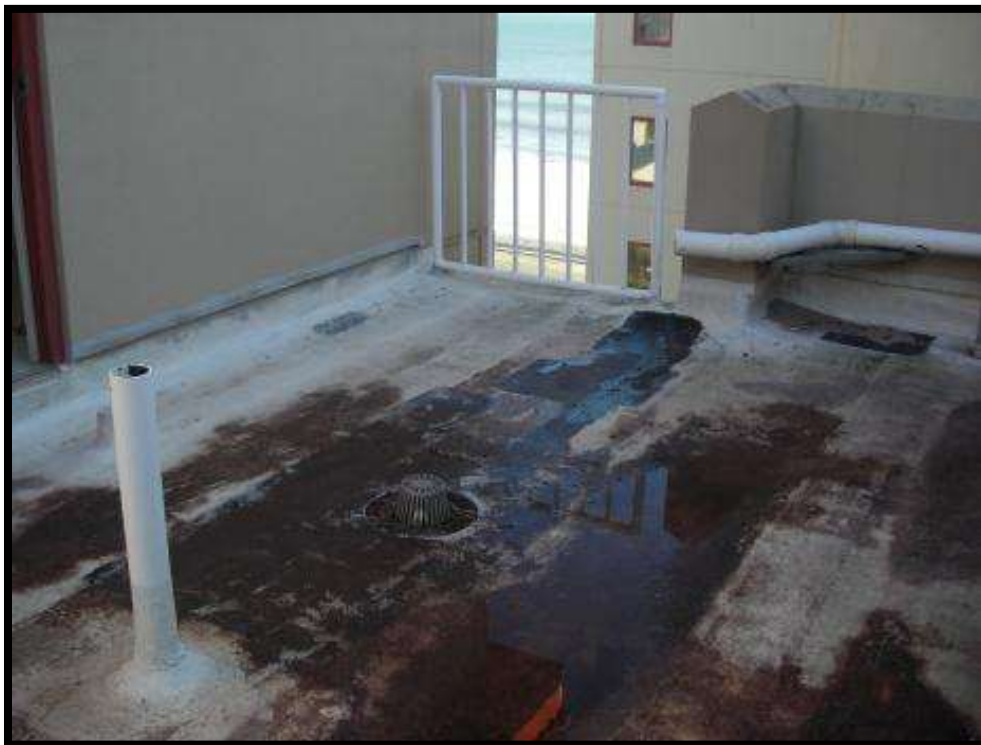
The upper low-sloped roofs did not exhibit damage from wind. These roofs were found

to be aged, and in some areas, found to have deteriorated roofing membranes. The lower low-sloped roof at the entrance and canopy area was found to have some damage along the north edge of the roofing membrane.

Photo 8: View of one of the low-sloped upper roof.

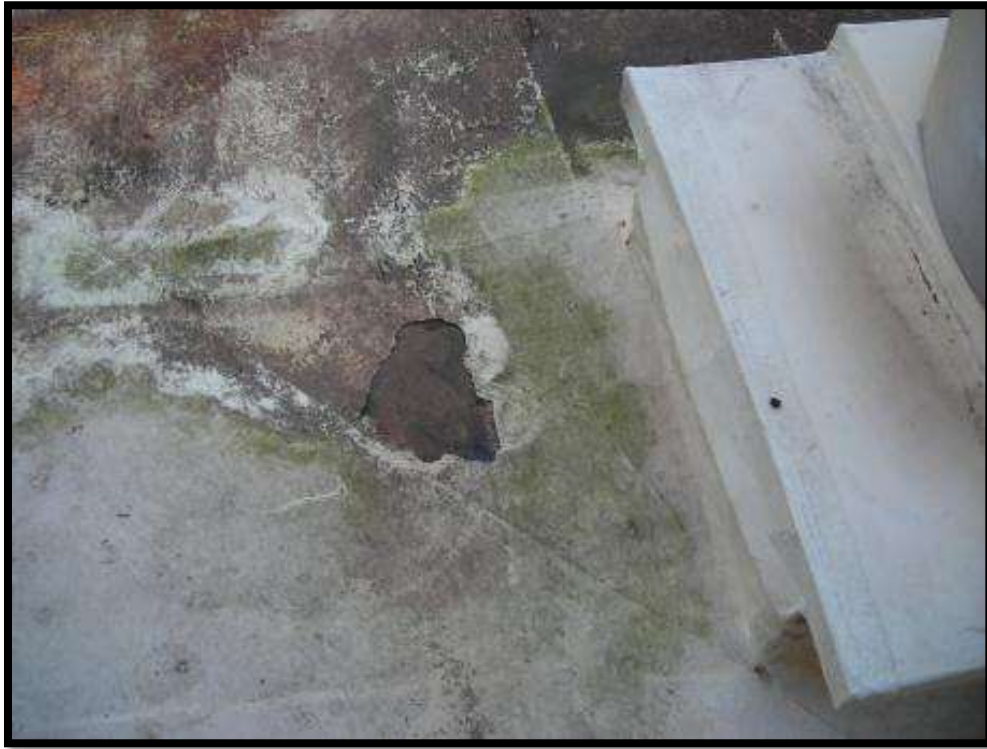
Photo 9: View of aged and deteriorated roof membrane (TPO).

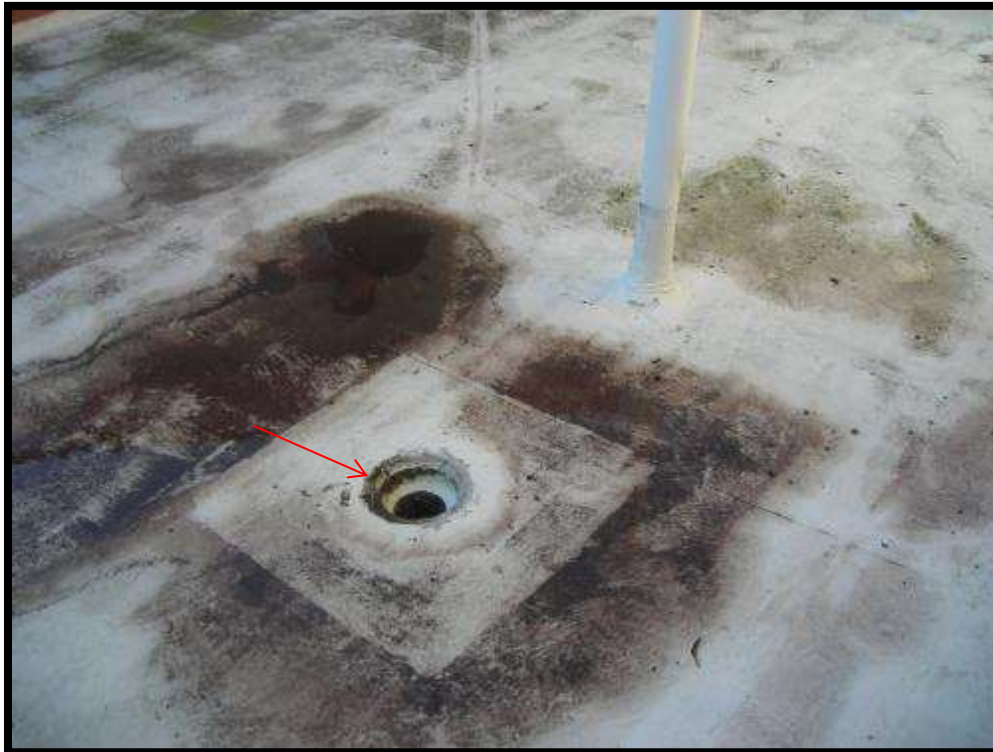
Photo 10: View of missing screen from field roof drain.

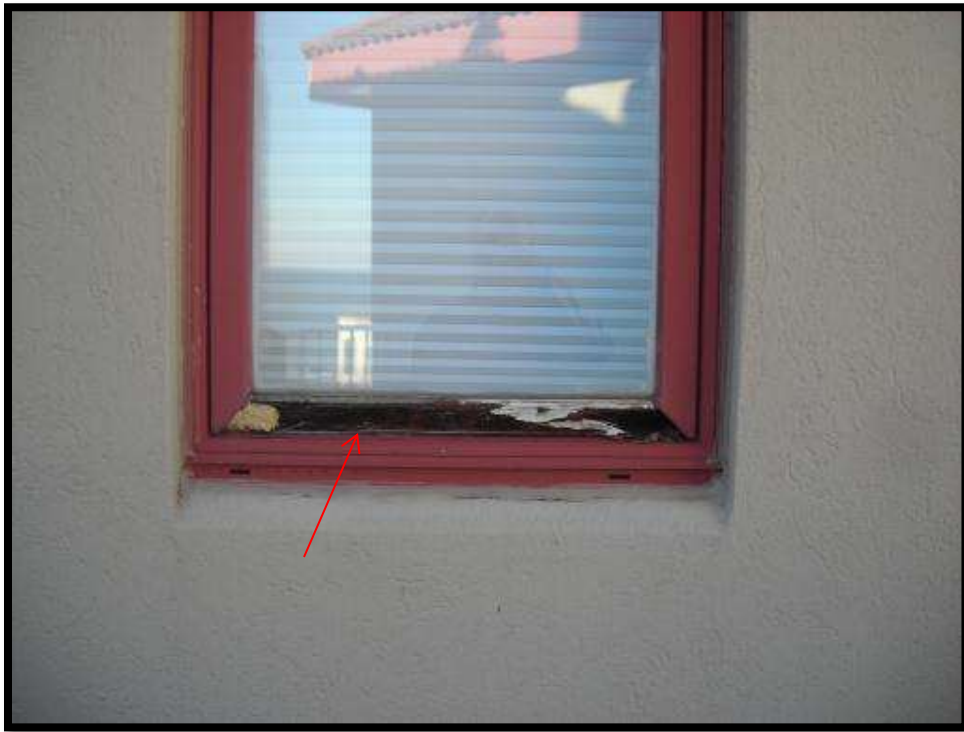
5. An exterior window frame from Unit 704 facing the upper, low sloped roof was observed to have its bottom sash exposed from its cladding. This area of the wall plane was observed to be in a deteriorated state from rot (Photo 11).

Photo 11: View of damage to bottom sash of window (Unit 704).

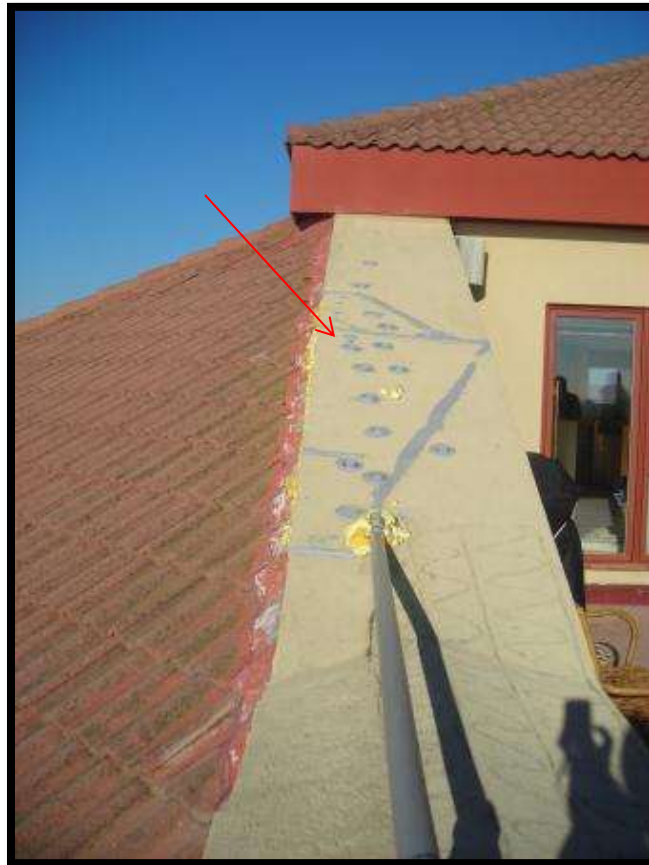
6. In Unit 704, a sloped EIFS wall cap at the balcony separates a hip tiled roof from the balcony was observed to have been recently damaged. This area had been repaired in place. The repair consisted of sealing the cracks and fastening through the sloped EIFS wall cap to the interior wall framing with tin-capped screws (Photo 12).

The damage to the EIFS wall cap along a demising sloped framed wall along the south side of the balcony of Unit 704 appears to have been associated with the effects of negative wind pressures. The gouges and holes found in several of the EIFS panels located along the east and north elevations appear to have been associated with wind borne debris experienced during the event..

Photo 12: View of sloped EIFS wall cap damage (View from balcony of Unit 704).

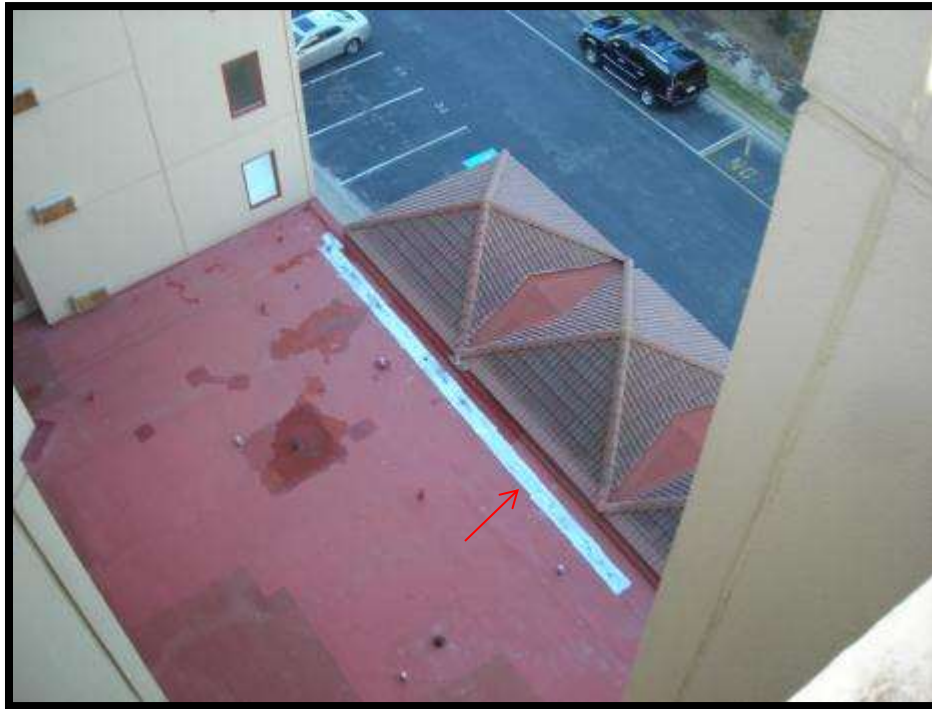
7. There were several areas of the lower canopy roof that were observed to have been repaired. The repair consisted of several patches, with a concentration of repairs along the north edge of this roof area (Photo 13).

Based on ASCE Standard 7, the perimeter edge of the roof typically is associated to higher wind pressures than the field roof areas. The lower sloped canopy roof, similarly to the upper low-sloped roof areas, was also aged.

As a result of age of the roofing membrane, the northern edge of this roof may have sustained some damage from wind pressures associated to higher than normal wind experienced during the event. There was no visibly apparent evidence of structural damage to the structural framing of the roofs including the upper hip roof, upper and lower low-sloped roofs.

Photo 13: View of lower low-sloped canopy roof.

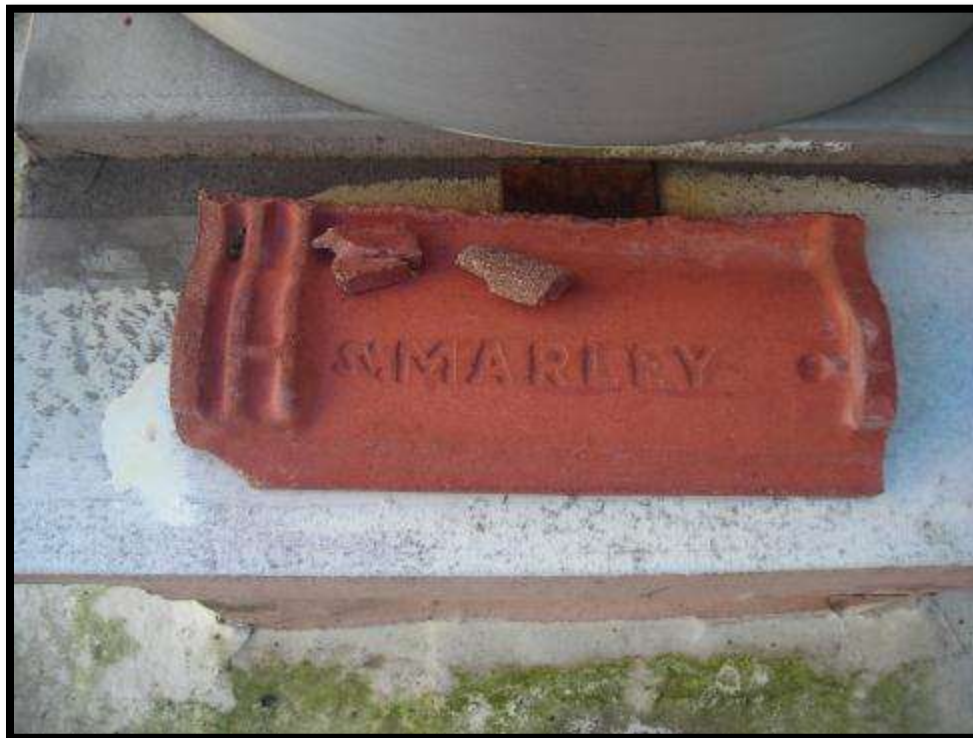
8. There was a dislodged tile found on one of the low-sloped upper roofs. The concrete tile appeared to have been a double pan tile manufactured by "Marley" (Photo 14).

Photo 14: View of dislodged concrete roof tile.

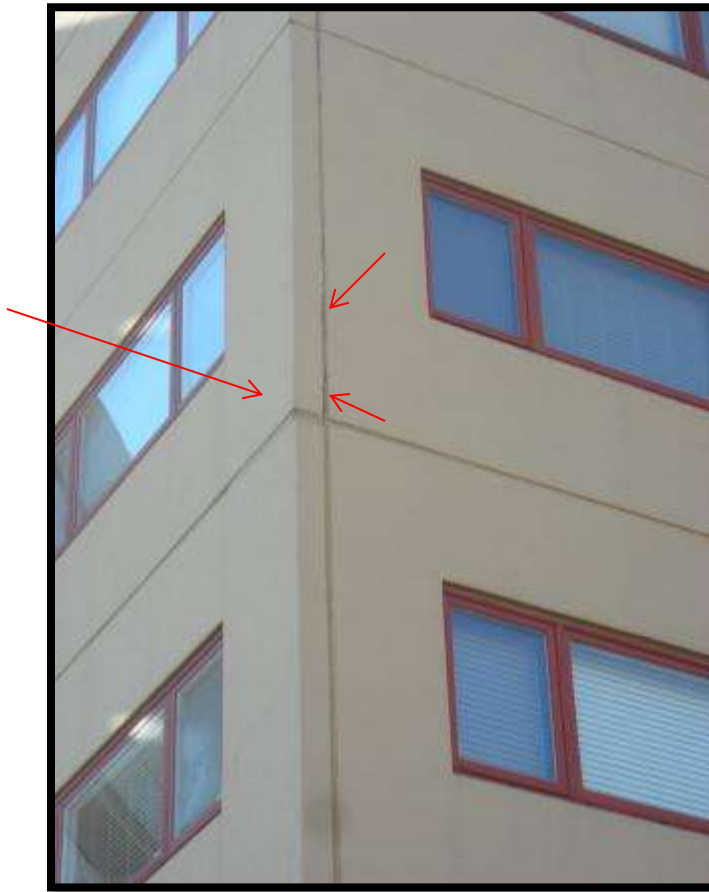
9. One of the EIFS wall panels along the east side building corner was observed to have been displaced outwards from its static position. The damage to the EIFS wall panel was noted to have been located between the 3rd and 4th floors along the east elevation of the building, at the north-east corner (Photo 15).

The damage found along the east elevation exterior wall at the EIFS wall panel located at the northeast corner of the subject building appears to be a result of wind forces. According to ASCE 7, exterior corner areas of building are categorized as having high negative pressures, when compared to interior field areas of walls, when the building is subjected to wind forces.

The EIFS wall panel along the northeast corner appears to have been pulled outwards from the bottom corner and exposed edge. This damage appears to be associated with the effects of negative wind pressures that the exterior walls experienced during the event.

Photo 15: View of damage to EIFS wall panel along corner of building (North-east corner).

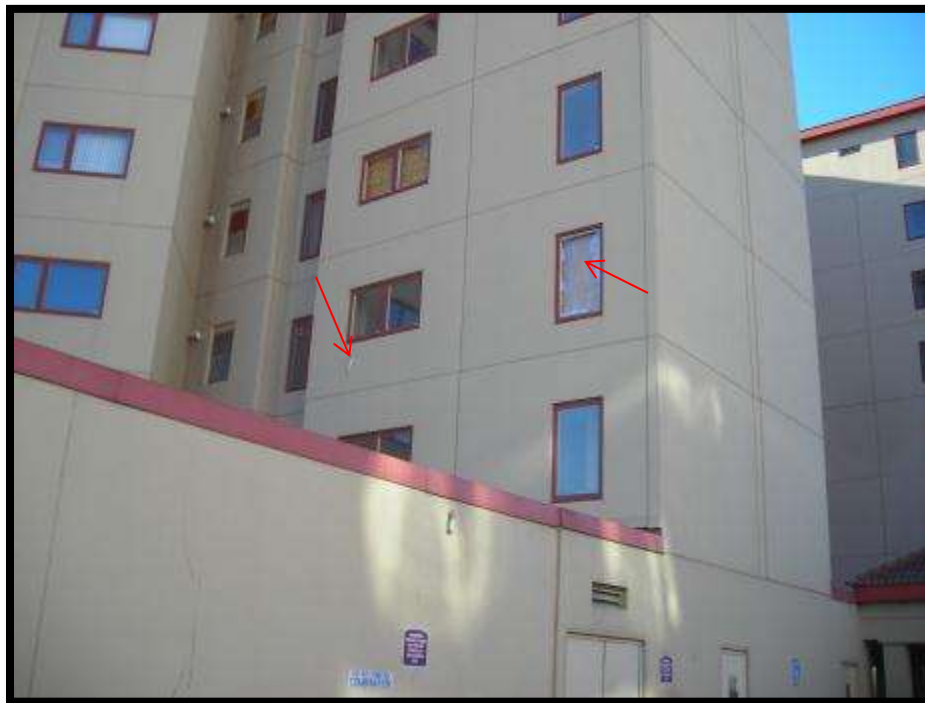
10. There were several gouges observed at the EIFS wall located at the north end tower of the east elevation of the building, along the 3rd level (Photo 16).

11. There was glass broken from an exterior window located at the north end tower of the east elevation of the building, along the 3rd level (Photo 16).

Photo 16: Gouge in EIFS wall (East elevation, 3rd floor level).

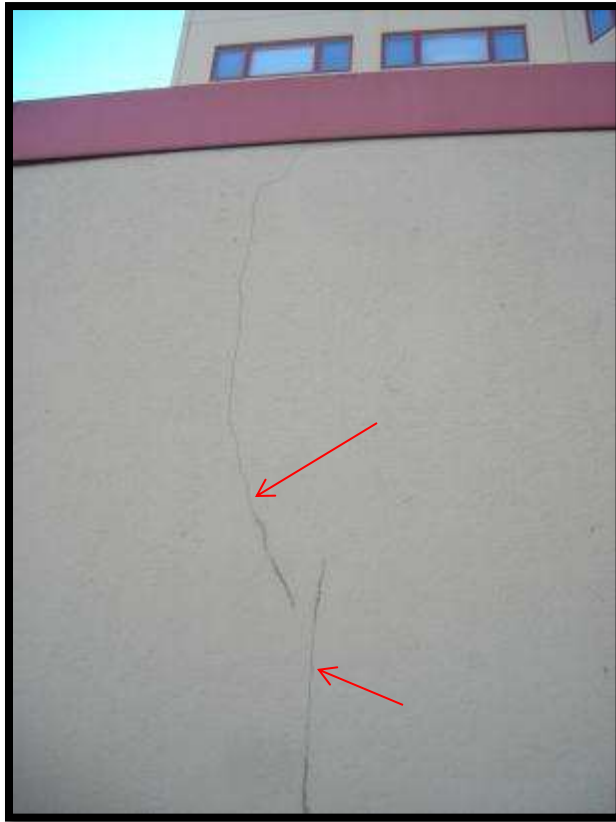
12. There were several hairline and minor cracks (less than 1/16-inch wide) observed along the painted stucco exterior stucco used at the CMU block walls along the north elevation of the building (Photos 17, 18 and 24).

The hairline and minor cracks found along the north elevation exterior EIFS and CMU block walls do not appear to have been formed as a result of the wind experienced during the event. These cracks appear to have been formed as a result of thermal and environmental changes that these building materials would be normally subjected to over the years from their original construction. These cracks appear to have formed along the outer stucco finish surface. These cracks are cosmetic cracks and do not alter or affect the structural strength, soundness or integrity of the building structural system.

Photo 17: Hairline crack in CMU block wall (North elevation).

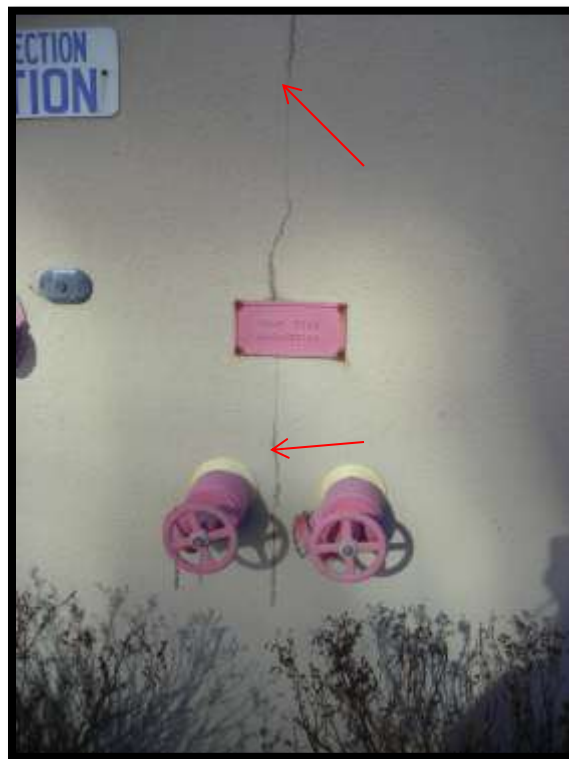
Photo 18: Hairline crack in CMU block wall (North elevation).

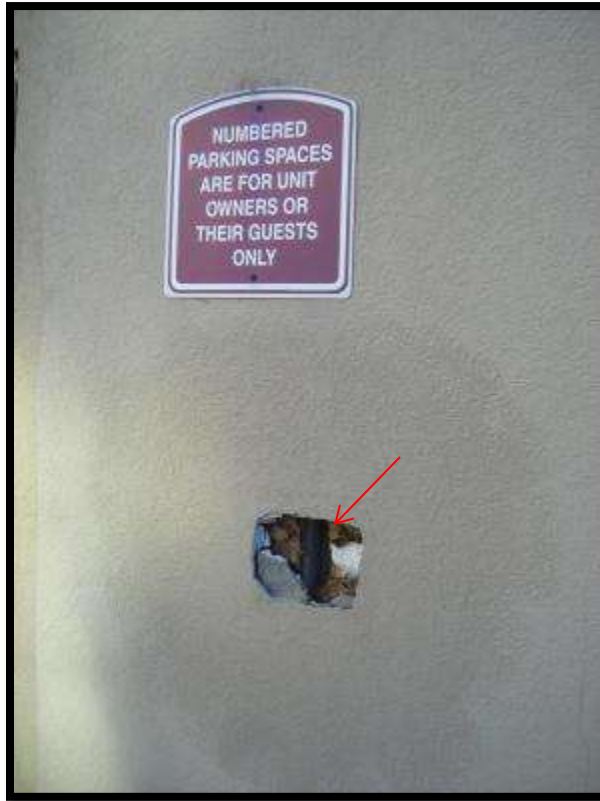
13. There were several holes observed along the first floor level EIFS wall panels located along the north exterior walls, to the east of the covered front door entry (Photos 19 through 21). In some of these areas, the protective coating along the exterior EIFS was observed to have a slight discoloration.

Photo 19: Hole in EIFS wall (North elevation).

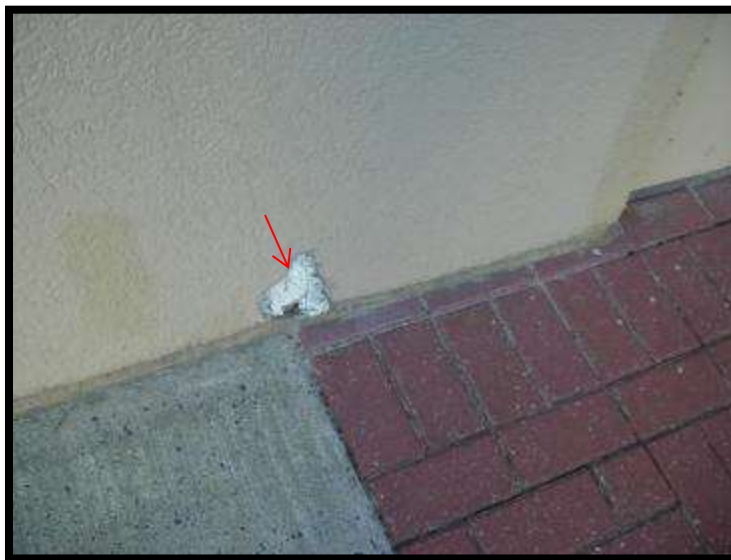
Photo 20: Gouge in EIFS wall (North elevation).

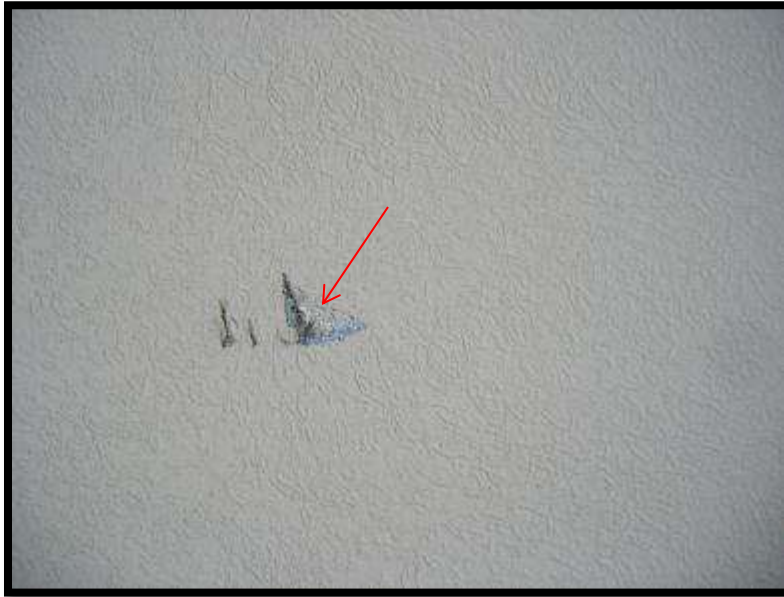
Photo 21: Gouge on EIFS wall (North elevation).

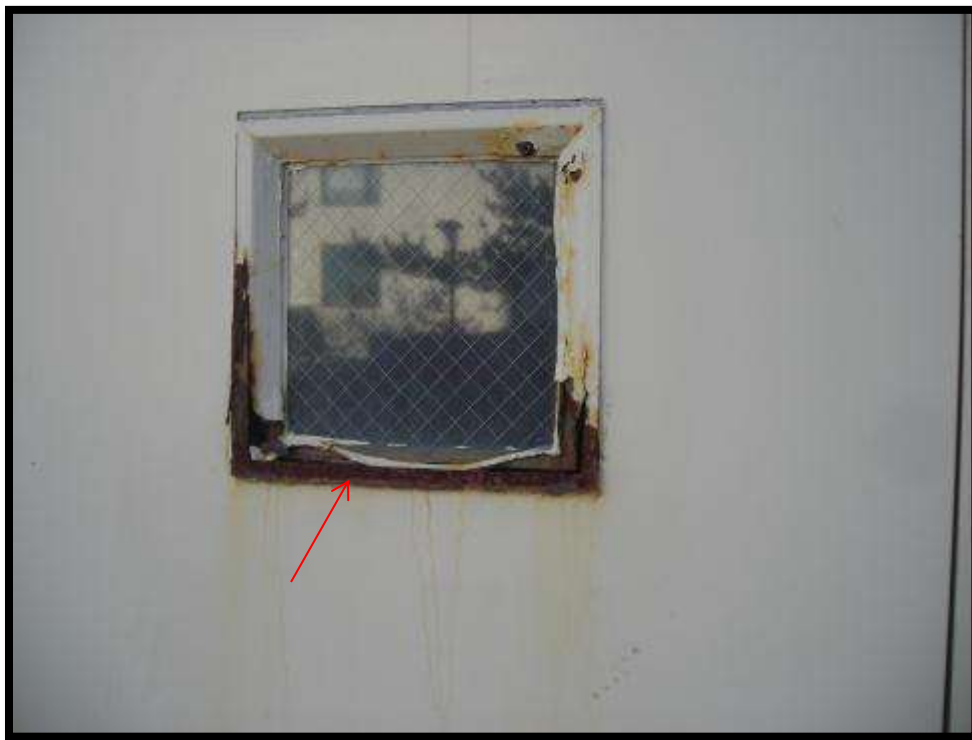
14. The metal doors along the north elevation, in the same general area as where the holes were observed to the EIFS wall, were observed to have been extensively corroded and damaged along the bottom sill area and around the door frame (Photos 22 and 23).

Photo 22: Damage to metal frame surrounding window of metal door (North elevation).

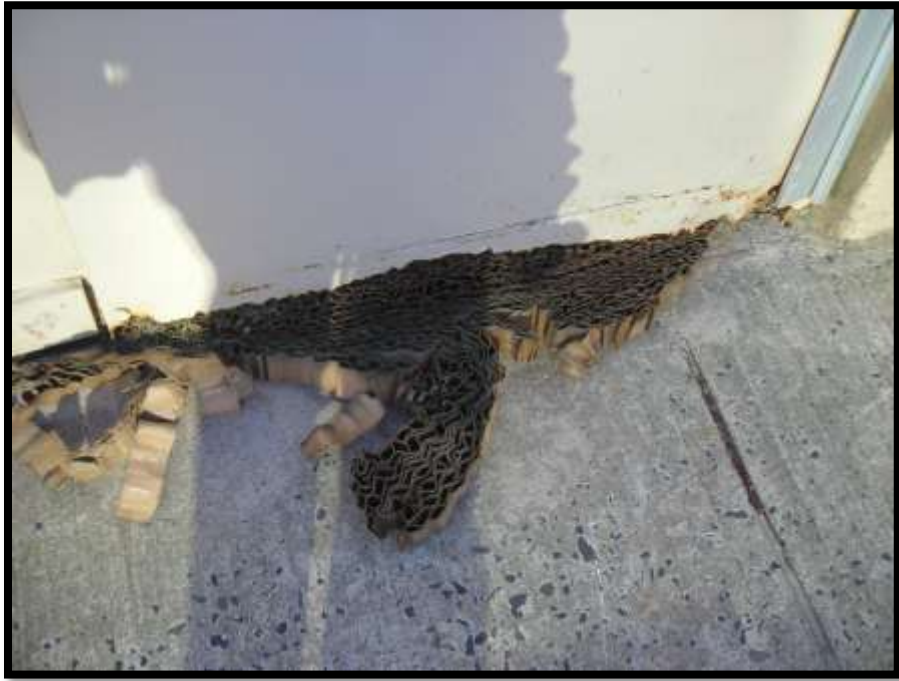
Photo 23: Damage to metal door sill (North elevation).

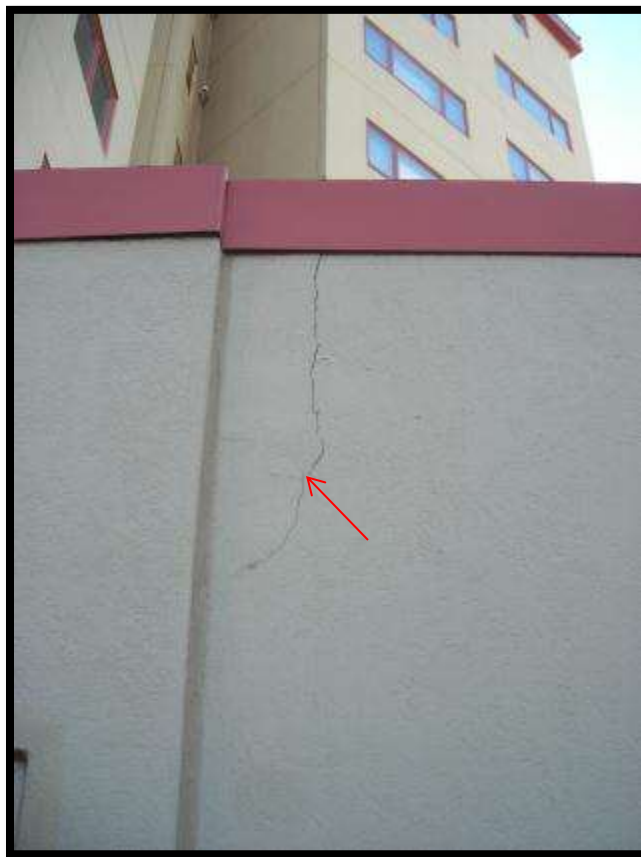
Photo 24: Hairline/minor crack in CMU block wall (North elevation).

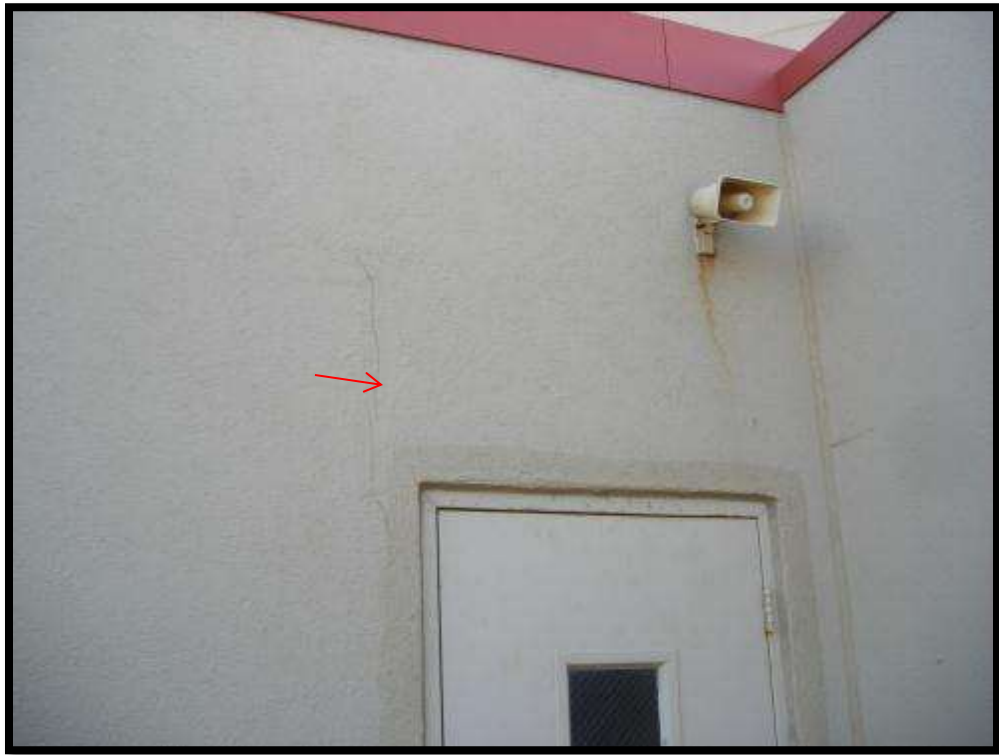
15. There was a hairline crack observed along the west elevation wall at the first floor level, located above a door header (Photo 25).

Photo 25: Crack in exterior first floor level wall (west elevation).
