HALLIWELL

RE:	Claim No.:	TBD
	DOCUMENT TYPE:	INVEST-ENGINEERING REPORT
	Date of Loss:	October 29, 2012
	Insurance Carrier:	Lexington London Insurance Company
	Insured Name:	Sand Castle Condominium
	Policy No.:	41LX006437850-8
	Location of Loss:	Sand Castle Condominium 384 Ocean Avenue Long Branch, NJ
	Independent Adjuster:	Mr. Richard Swink, NGA
	IA File No.:	YKFS-20861
	HEA Project No.:	12-997

The purpose of this investigation was to provide an engineering opinion as to the cause and origin of the reported damage to the roof and along the Exterior Insulated Finish System (EIFS) walls of the subject Condominium.

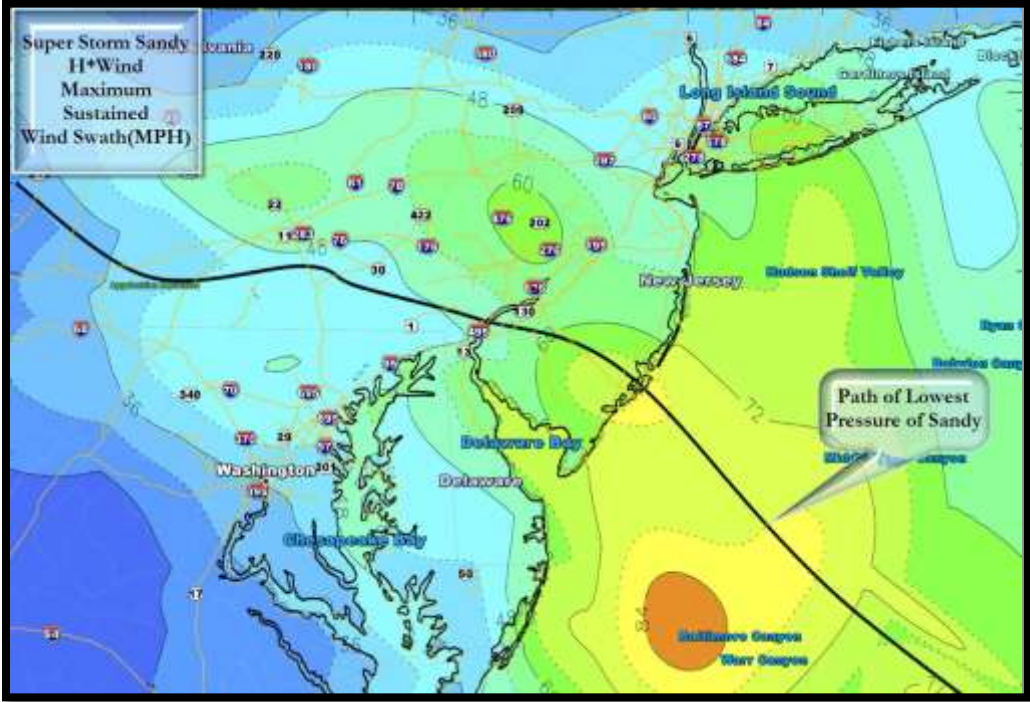
The National Hurricane Center (NHC) has not released a post-storm report on Super Storm Sandy as of the date of this report. The Hurricane Research Division (HRD) of the Atlantic Oceanographic and Meteorological Laboratories (AOML) at the National Hurricane Center released the H*Wind maximum sustained wind swath of winds that occurred during Super Storm Sandy (see Figure 1).

Figure 1: The wind swath of H*Wind maximum sustained winds that occurred during Super Storm Sandy as released by the Hurricane Research Division (HRD) of the Atlantic Oceanographic and Meteorological Laboratories (AOML) at the National Hurricane Center (NHC).

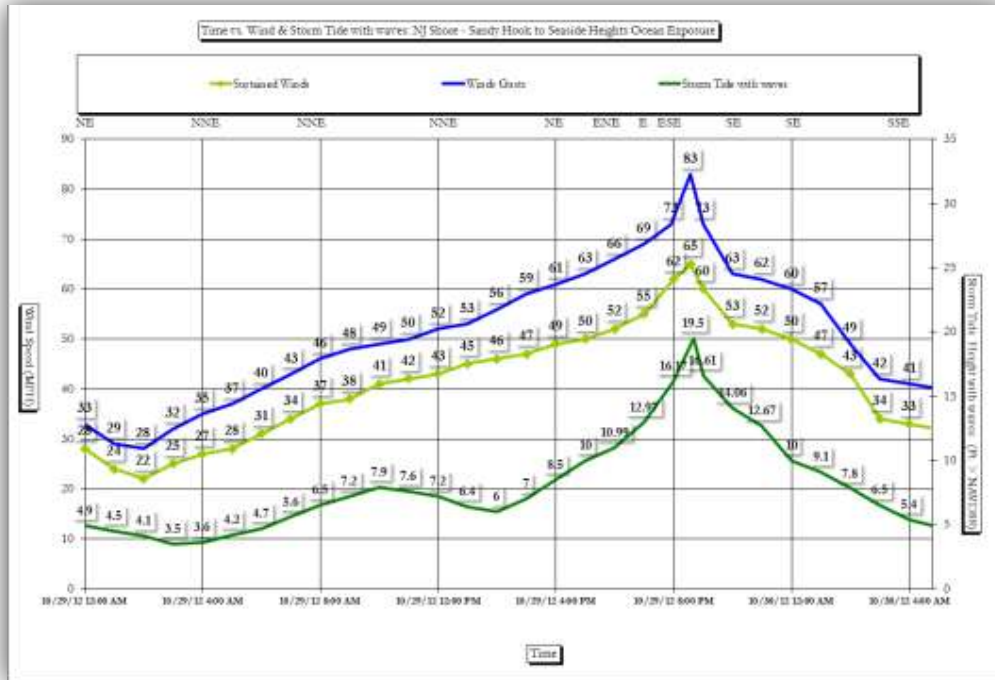
Figure 2 is a timing graph from this analysis. This graph shows that the wind speed peaked (65 mph sustained, 83 mph 3-second gust) at approximately 8:35PM EDT on October 29, 2012 from an east-southeast direction.

Figure 2: Forensic meteorological analysis of the timing of the sustained and 3-second gust wind speed and direction, as well as an analysis of the storm surge and wave heights, and timing for the coastline of New Jersey from Sandy Hook, south to Seaside Heights.

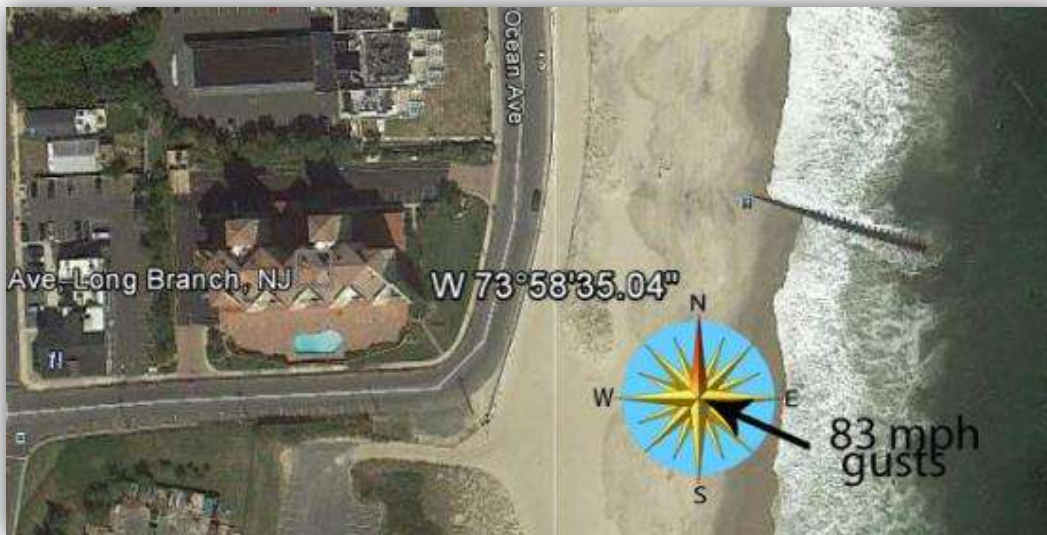
Figure 3 is an aerial view of the subject property, with a wind rose indicating the direction and magnitude of the maximum wind gusts that affected the subject building during Super Storm Sandy.

Based on HEA analysis of the preliminary data available at the time of this report, we estimate that the maximum sustained winds at the subject site were 65 mph, below the range of a Category 1 (74 – 95 mph) hurricane, with maximum 83 mph wind gusts, from the east-southeast at 8:35 PM on October 29, 2012.

Figure 3: Super Storm Sandy Maximum Wind Speed and Direction at Subject Building

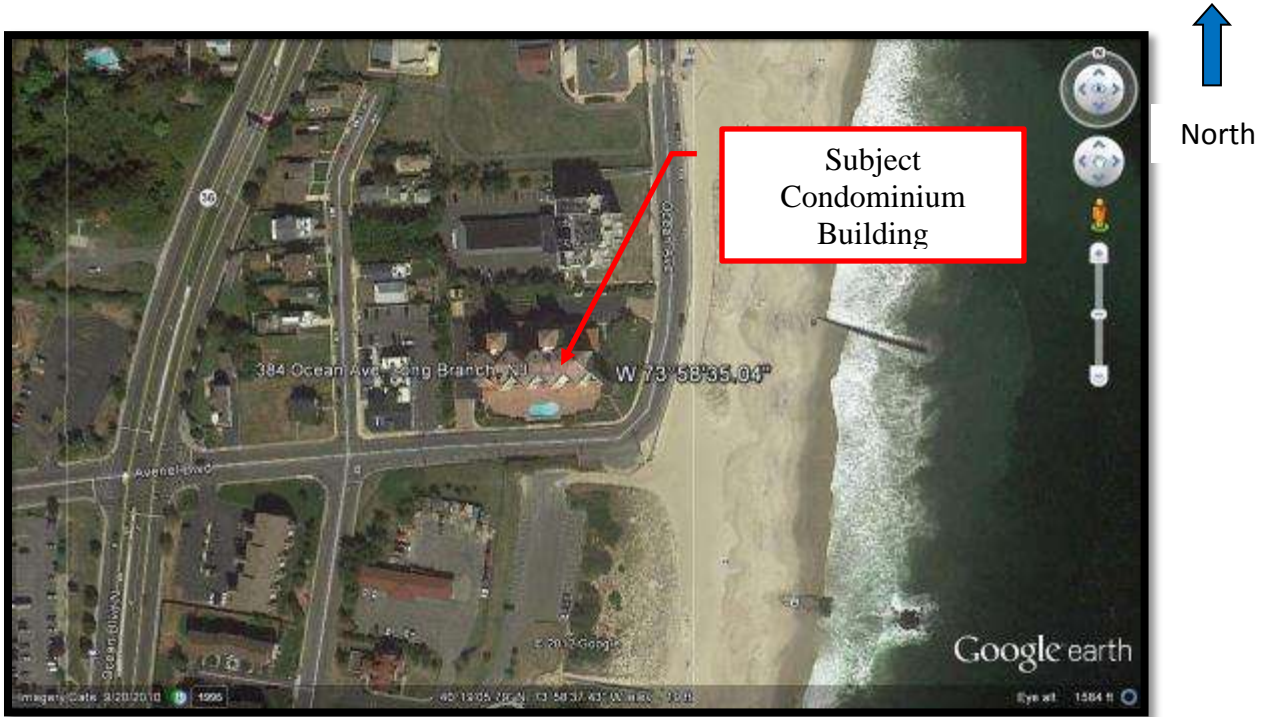
The subject Property is located in Monmouth County, New Jersey. According to Monmouth County Property Appraiser's website, the Property was constructed in 1994. The Property is located east of Highway 57 (Ocean Blvd), north of Avenel Blvd along the coastal shoreline of the City of Long Branch, NJ (Photo 1).

Photo No. 1: Aerial photo of site retrieved from Google Earth.
